JS|HELD

WHITE PAPERS &  
RESEARCH REPORTS

## Fourier-Transform Infrared (FTIR) Technology & Analysis

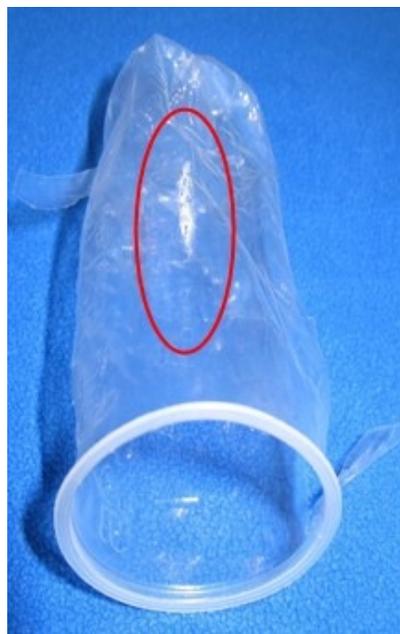
*Figure 1 - Wax-like contamination on the surface of polyethylene plastic baby bottle liners.*

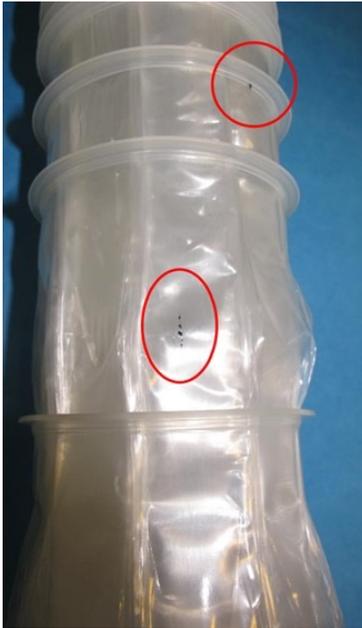
**Figure 2** - Black contamination on the walls of the liners.

The black spots seen in Figure 2 were examined under a dissecting microscope and determined to be embedded within the polyethylene liners and not on the surface of the material. Figure 7 shows one of the embedded black spots in cross-section after it was transected with a scalpel.

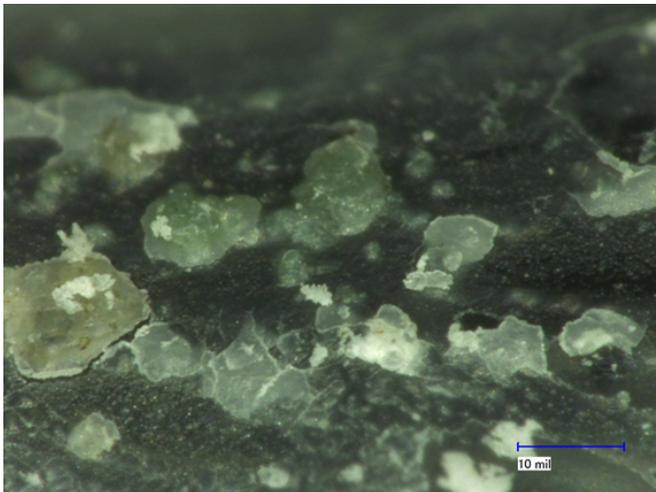
A small fragment (5/1000 inch) of the lighter colored contaminant, shown in the microscope view in Figure 3, was analyzed by FTIR and identified as containing phenyl phosphite (Figure 4), an anti-oxidant commonly used in processing of polyethylene (PE) to prevent thermal degradation at high temperatures. The FTIR spectra also contained extra peaks not associated with the antioxidant as shown by the red markings in Figure 4.

**Figure 3** - Deposit on the surface of the baby bottle liner seen under digital microscope at 200 times magnification.

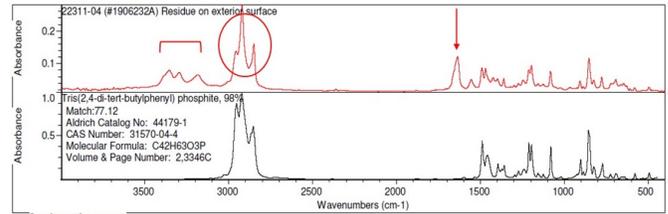
**Figure 4** - FTIR spectra of contaminant #1 compared to a phenyl phosphite anti-oxidant.

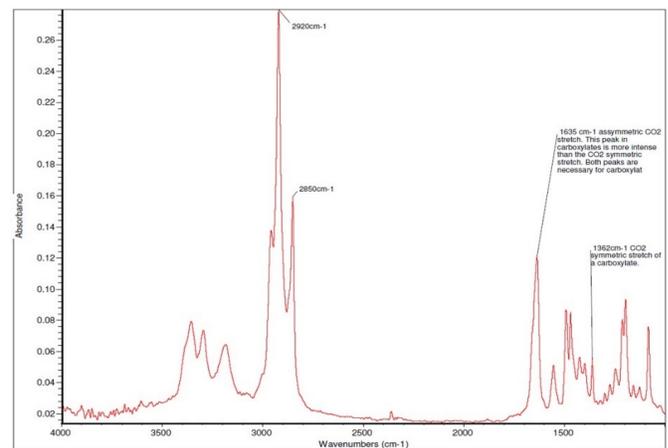
Figure 5 shows the result of spectral subtraction performed on the spectra to remove or “subtract” the phenyl phosphite peaks and reveal the masked or hidden substance(s). Peaks in the “fingerprint” region show strong evidence of a carboxylate such as a stearate. Stearates are wax-like or soap-like substance derived from fatty acids in vegetable oils or fats such as coconut and palm oils. Carboxylates can be identified by their characteristic peaks at wavenumber 1635 cm-1 and 1362 cm-1 with the former relatively more intense than the latter as evident in the FTIR spectra in Figure 5.

**Figure 5** - Resulting spectra after subtraction of phenyl phosphite.

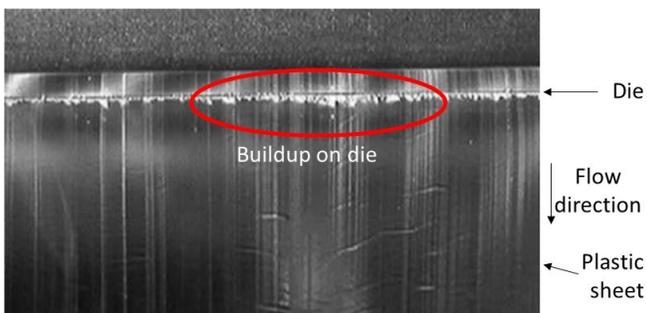
erucamide will “bloom” lightly to the surface but the concentrations will be so low as to not be visible. However, when excessive amounts of processing aids such as lubricants and slip compounds are used and/or a higher density resin is used than was intended, (e.g., HDPE instead of LDPE), the additives can form deposits on surfaces of molds, dies, or other processing equipment and later slough off on to the plastic during production. The phenomenon is known as “plate-out” or “die drool.” Figure 6 shows an extreme example of the buildup on the die of a plastic sheet extrusion machinery die. It was concluded that erucamide/antioxidant plate-out residue had accumulated on the die and deposited on the thin sheets that were later thermoformed into the baby bottle liners.

**Figure 6** - Molten polyethylene is pushed through a metal die to form thin sheets for later thermoforming of liners. Plate-out or “die drool” seen here is the buildup of additives on the die and can later sluff off onto the plastic.

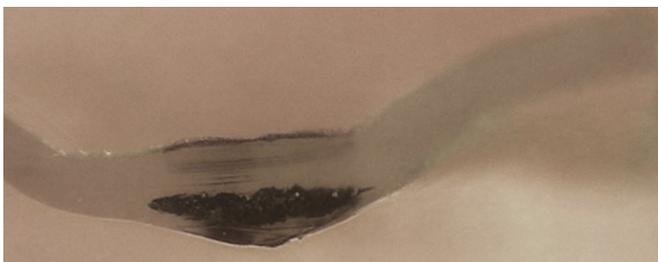
**Figure 7** - Cross section of black particle and liner showing that it was embedded in the bulk of the polyethylene liner.

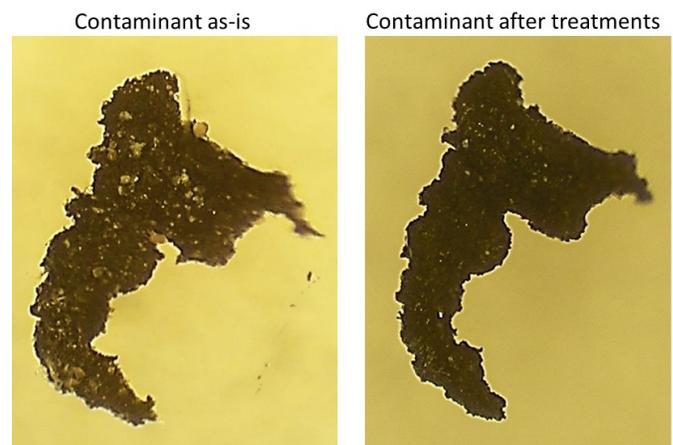
The black particles had a rubber-like consistency. FTIR analysis of the black spots did not positively identify the rubber-like material as it was masked by the numerous crystalline particles which overwhelmed the signal. The spectra indicated that the crystals were calcium carbonate, a common filler used in rubbers to improve their physical properties. FTIR spectral subtraction was attempted as before but the results were inconclusive. A small amount of hydrochloric acid (HCl) was added to one of the particles to remove the calcium carbonate resulting in carbon dioxide gas and a water soluble salt that can be rinsed away leaving the rubbery material in isolation. Figure 8 shows digital microscope images of one black particle before and after the HCl treatment and rinsing. Note the large number of crystals in the as-is or pre-treatment image (left) and the relative lack of crystals in the post-treatment image (right).

**Figure 8** - Extracted black particle before (left) and after HCl treatment and rinsing with water (right).

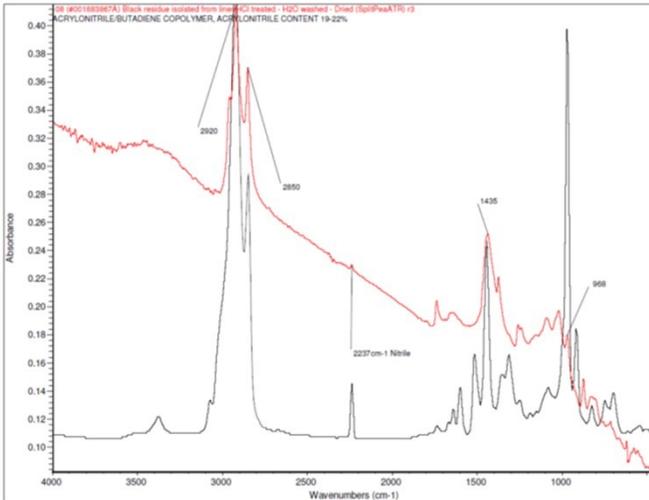
Figure 9 is the FTIR spectra of the cleaned rubber particle and the spectra of Buna-N rubber showing an excellent match. Calcium carbonate filled Buna-N rubber is commonly used for rubber O-rings, washers, and gaskets. The contaminants were traced back to manufacturing equipment. The O-rings were found to have been deteriorating, resulting in small particles breaking off into the molten polyethylene and becoming embedded in the liners.

**Figure 9** - FTIR scan of cleaned black rubber particle sans calcium carbonate filler compared to acrylonitrile butadiene rubber or Buna-N.

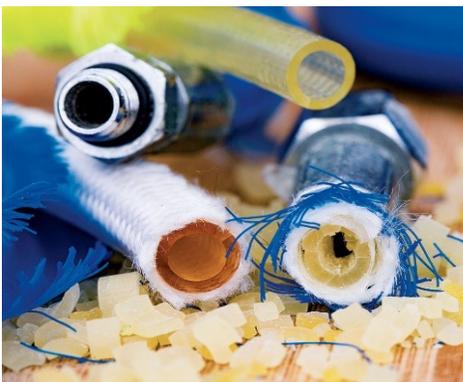
Reports described scuba air hoses failing internally and plugging up regulators that deliver breathing air to the diver. The failed hoses ranged in age from about 3-8 years and were generally located in tropical areas. The braided hoses showed no outward sign of deterioration; however, when the hoses were cut open, deterioration to the internal rubber hoses was clearly visible (Figure 10 and Figure 11).

**Figure 10** - TPU scuba air hoses at various stages of degradation.

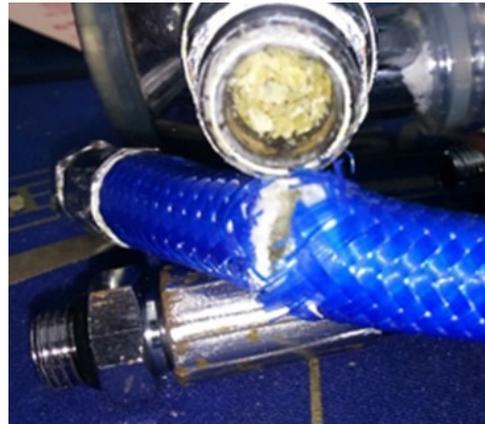
**Figure 11** - Severely degraded TPU hose clogging air hose.

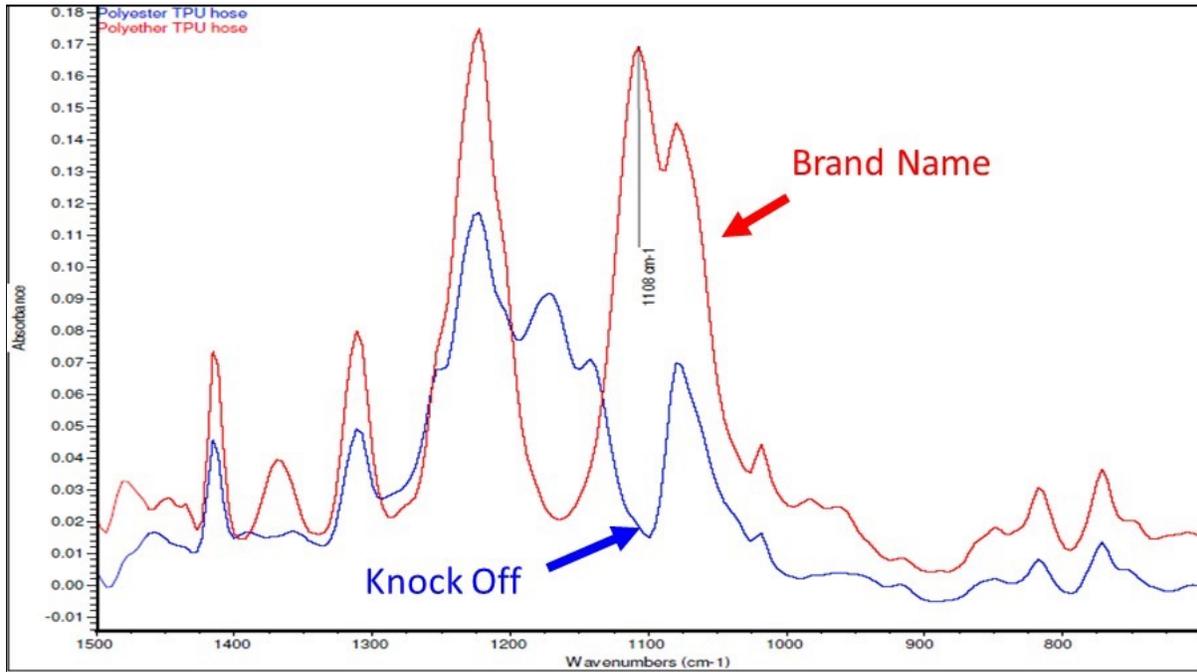
**Figure 13** - FTIR spectra of knock off and brand name TPU hoses. Note the presence of the ether peak at 1108 cm-1 for the brand name hose and its absence in the knock off hose.

The presence of this peak indicated that the brand name TPU contained a chemical bond called an “ether” linkage, and the lack of such a peak in the failed and knock-off TPUs indicated an “ester” linkage connecting the polyurethane portions of the molecule.

This distinction is important because TPUs with ester linkages (polyester TPU) are known to be susceptible to hydrolytic degradation while TPU with ether linkages (polyether TPU) are much more resilient to this type of decay. Testing and analysis showed that the combination of moisture in contact with the rubber hoses, the higher temperatures found in tropical environments, and, critically, the use of polyester (versus polyether) type TPU material for the hoses caused the rapid deterioration and failure of the scuba air hoses. Even though both air tubes were made from TPU, the specific polymer chemistry chosen to make the failed tubes was inappropriate for the application, being highly susceptible to environmental degradation and potentially leading to clogging of the second stage regulator of a scuba diver, in turn leading to loss of air supply. Consequently, the Consumer Products Safety Commission (CPSC) was notified, and corrective measures have been taken to address the issue.

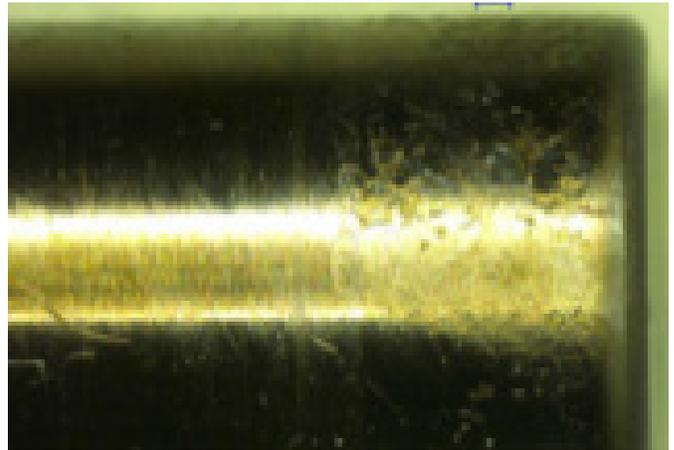
Incident fuel filter and fuel injectors were obtained for examination (See Figure 15 and Figure 16). Disassembly of the injector proved difficult as the needle valves were stuck in their housings. Once taken apart, wax-like deposits were observed on the solenoid piston (Figure 17) and light-colored deposits were observed on the surfaces of the solenoids, needle valves, and needle valve housing bores as shown in Figure 18 and Figure 19. FTIR and SEM-EDS analyses were performed to provide chemical structure information and elemental composition of the deposits.

**Figure 17** - Blunt end of needle valve from injector showing deposits, 50X magnification.

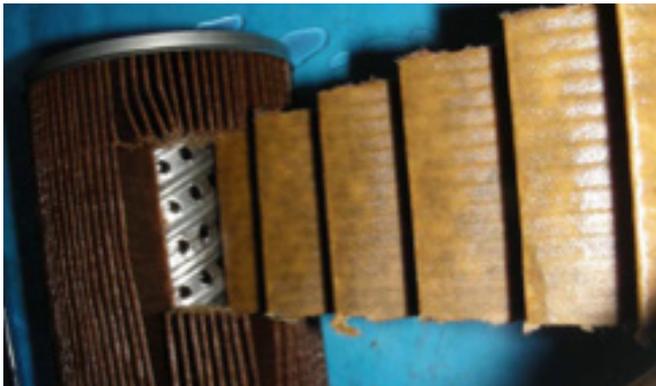
**Figure 15** - Secondary fuel filter section removed for examination.

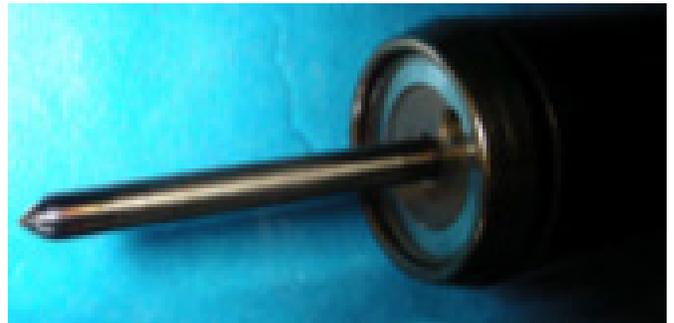
**Figure 18** - Fuel injector with needle stuck in the injector bore.

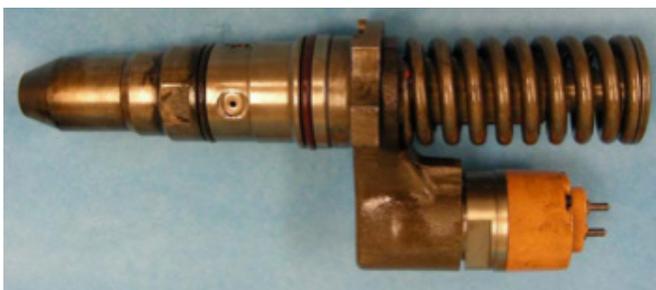
**Figure 16** - Clogged fuel injector from one of the vessel's diesel engines.

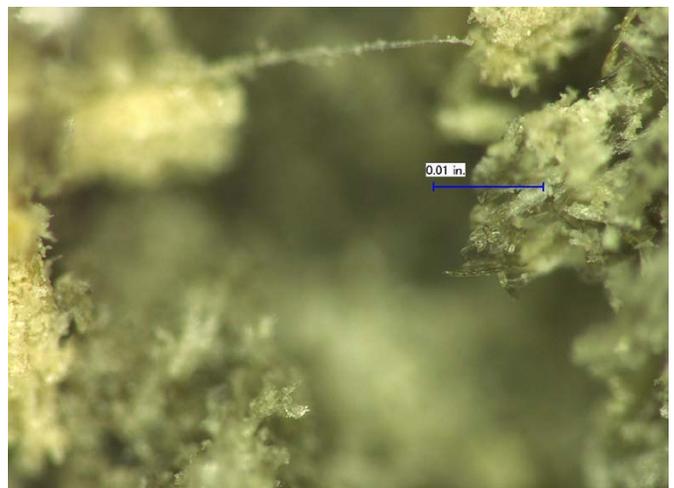
**Figure 19** - Scrapings from needle valve housing (bore), 200X magnification.

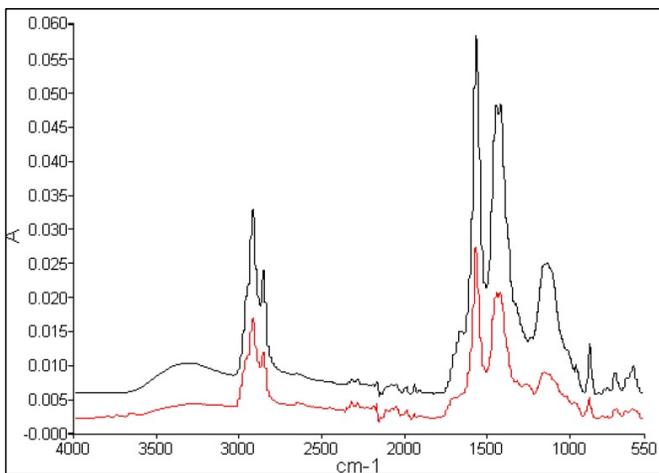
FTIR spectrum of all deposits, including the surface of the fuel filter, showed similar chemical structures. Representative spectra (shown in Figure 20) indicated “fatty acid soaps.” Elemental analysis of the deposits showed the present of sodium and/or calcium. These are the main counter ions in the fatty acid soap detected by FTIR.

Figure 20 - FTIR spectra of deposits on stuck fuel injectors.

It was concluded that the soap deposits were likely responsible for the improper function of the injectors. Additional information regarding fuel processing and fuel additives led to the conclusion that the formation of the soap deposits was likely the result of two classes of contaminants in the fuel—acidic corrosion inhibitors; introduced during the refining, storage, and/or transport process prior to delivery to the vessel; and sodium and/or calcium. Possible sources of sodium and/or calcium include contamination from sea water, salt-dryer filters used in the processing and refining of fuel, and chemicals used for cleaning the vessel’s fuel tanks. The third component that combined to form the soap deposits is the diesel fuel itself and/or biological growth (if water is present in the fuel). The soap formed was viscous and highly polar, capable of adhering to metal surfaces and “gumming up the works.” The presence of copper and zinc can accelerate such a process. Standard fuel tests currently in use were not effective for identifying the cause of the problem because the quantity of contaminants necessary for carboxylate formation which cause the injector failure was extremely small. The immediate solution to prevent injector failure was to prevent or remove formation of the deposits rather than try to identify the presence of contaminants in the fuel.

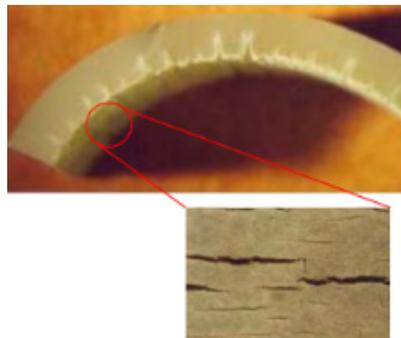
Many different types of pipes are used in potable water service. Often, claims involve premature failure of polyethylene (PE) and cross-linked polyethylene (PEX) pipes used in household domestic water systems. Figure 21 shows a severely degraded PE water pipe in cross-section with cracks on the inner wall surface. FTIR can be a powerful tool in the analysis of PE and PEX when determining degradation.

Figure 21 - Severely degraded inner surface of polyethylene water pipe.
