# PERSPECTIVES

## How Technology is Revolutionizing Complex Roofing Assessments

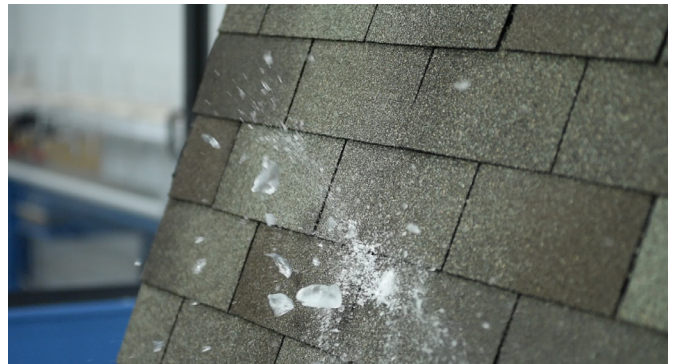
*Figure 1 - Impact Testing*

Disagreements often arise regarding causes of marks in roofing, especially when the marks are claimed to be attributed to hail. To identify possible hail strikes in the lab, comparative impacts are made against roofing samples with simulated hail in accordance with ANSI FM 4473-Test Standard for Impact Resistance Testing of Rigid Roofing Materials by Impacting with Freezer Ice Balls. For this, roofing membranes are supported in the same way as they were in the field and impacted by various sizes of ice balls propelled at free-fall speeds that are equivalent to those of similar sized naturally occurring hailstones. Qualitative comparisons are then made between the existing marks,

reportedly caused by the naturally occurring hail, and those of the simulated hail—assessing sizes of marks as well as the patterns of the marks. Impacts also can be made to develop threshold sizes for hail-caused damage to roofing.

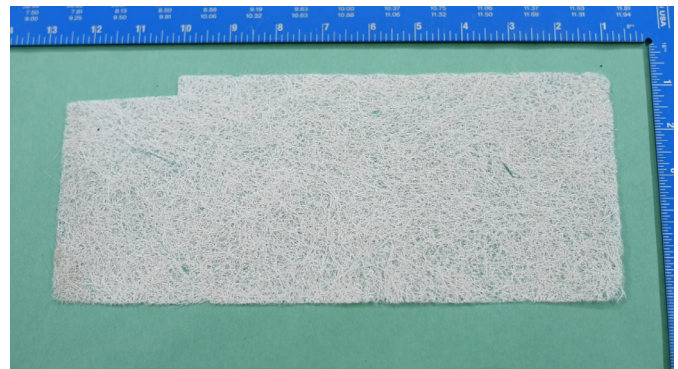
*Figure 2 - Roofing Membrane After Being Desaturated in Vapor Degreaser*

Regardless of the roof covering, samples are examined visually with both unaided eye and under magnification to discern punctures, tears, or bruises typical of hailstone impacts. Bituminous roofing, including built-up roofing (BUR) and modified bitumen (mod-bit), as well as composition shingles can be desaturated in a vapor degreaser and their reinforcements extracted and examined for fractures or strained regions characteristic of hail. For instance, fractures (other than anvil strike types) initiate in the lowermost reinforcement. Fractures are longest in the lowermost reinforcement and progressively shorten in reinforcements above. Plastic single-ply membranes can be examined while backlit by high intensity light. The light enables inspection of the reinforcement for fractures or strained regions within the plastic matrix without dissolving the plastic away.

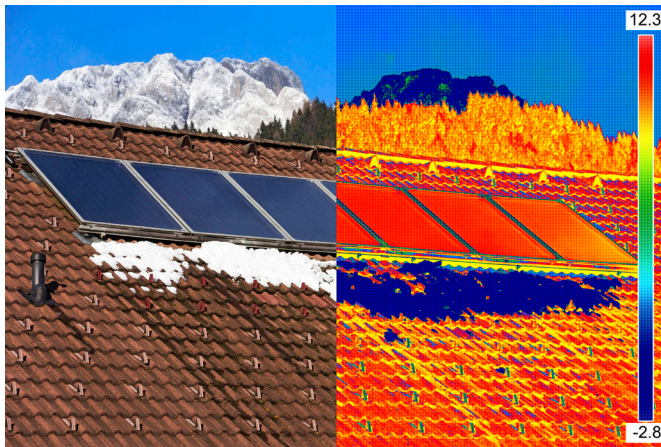
**Figure 3 - Comparison of Digital Image & Infrared Thermal Image**

Roof IR inspections must be conducted when the roof surface is dry, and when the interior of the structure is at least 18°F (10°C) different than the outdoor temperature. This difference in temperature allows for the areas holding potential moisture to be identified with the IR camera since the presence of moisture in an area of the roof will be cooler or warmer than the surrounding areas.

A common and significant misconception about the use of IR cameras for roof inspections is that IR cameras can detect moisture. It is important to note that thermal images depict thermal radiation patterns in materials and can be present on the surface from affected substrates; thermal images do not depict moisture or distinguish between wet or dry. Therefore, while irregularities or anomalies on roofs detected as thermal patterns may indicate potential locations of moisture, temperature differentials and variations in thermal patterns often occur due to a variety of other factors. For this reason, the analysis of the thermal images of roofs should be conducted by a properly trained, experienced, and certified Infrared Thermographer, utilizing additional field instrumentation and/or testing to evaluate whether temperature anomalies are wet conditions, cold conditions, or are related to conditions other than moisture.

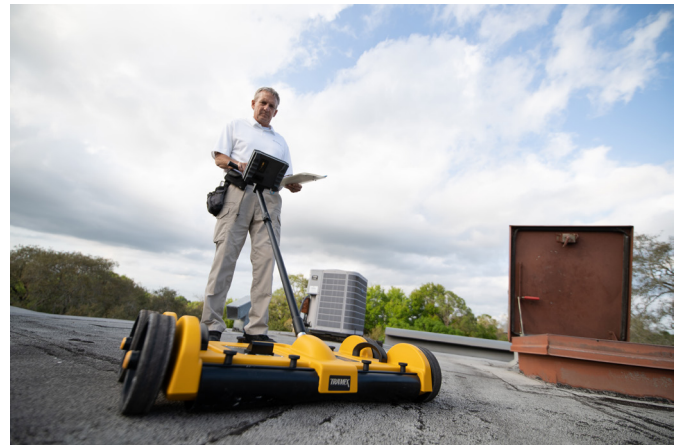
**Figure 4 - Evaluating Roofing Materials for Moisture**

With the use of any IR camera, it must be reemphasized that this is not a stand-alone tool and it only identifies a difference in thermal radiation, not the actual presence of moisture. Capacitance meters (or more commonly called moisture meters) are used as a secondary tool in locating moisture on a roof, but core samples are the ultimate necessity to confirm that the thermal patterns observed by the IR camera are actually the presence of moisture.

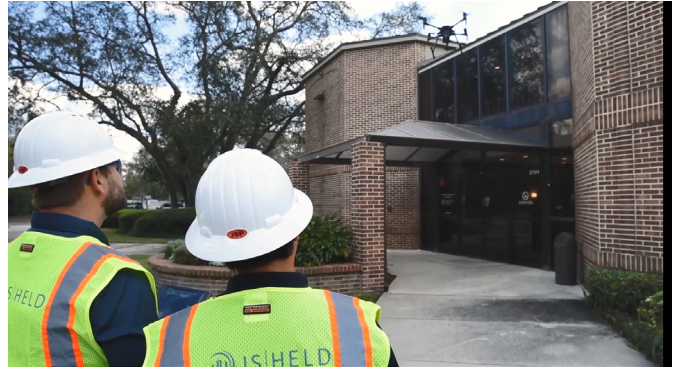
*Figure 5 - Drone Assessment*

Drones can be used to examine roof coverings from a close distance and the photographs/videos are high definition (typically 1080p or 4k resolution) which provides photographs with a level of detail similar to as if you were standing on the roof itself. The old adage “a picture is worth a thousand words” is even more profound when considering the vantage view from a drone hovering 100 feet above a building with a roof covering that has been removed by a hurricane. This simple picture can not only tell the story of the missing roof covering but could also provide valuable details as to complexity of repairs if access to the building was limited. Further, a drone can also assist with the documentation of roof appurtenances such as the number of HVAC units or curbs and roof features, such as chimney saddles or slope transitions.
