JS|HELD

WHITE PAPERS &  
RESEARCH REPORTS

## Fourier-Transform Infrared (FTIR) Technology & Analysis

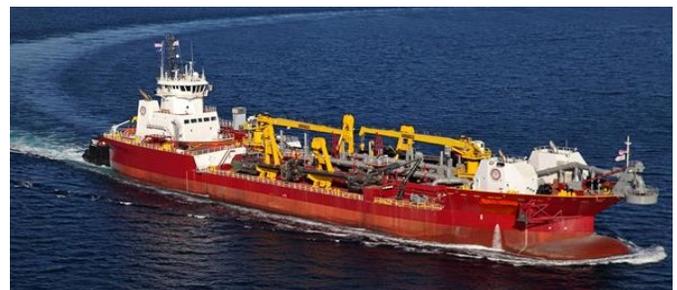
**Figure 14** - Hopper dredge marine vessel.

A large, 400-foot-long hopper dredge ship, similar to the one pictured in Figure 14 operating in the Gulf of Mexico, was powered by three diesel engines that experienced a series of fuel injector failures after receiving fuel. The ship’s log showed the vessel lost approximately 22 injectors and, at one point, all propulsion was temporarily lost as the vessel was coming

into port, which could have resulted in a collision with the dock or another vessel had one of the engines not restarted. The ship became so debilitated that it had to be taken out of service to affect repairs.

Laboratory analyses were conducted by third-party labs on fuel samples from the refueling barge and debilitated dredge vessel. The problem was perplexing because the fuel injector failures occurred soon after refueling, and yet nothing from the fuel analysis explained these occurrences.

It was concluded that the soap deposits were likely responsible for the improper function of the injectors. Additional information regarding fuel processing and fuel additives led to the conclusion that the formation of the soap deposits was likely the result of two classes of contaminants in the fuel—acidic corrosion inhibitors; introduced during the refining, storage, and/or transport process prior to delivery to the vessel; and sodium and/or calcium. Possible sources of sodium and/or calcium include contamination from sea water, salt-dryer filters used in the processing and refining of fuel, and chemicals used for cleaning the vessel’s fuel tanks. The third component that combined to form the soap deposits is the diesel fuel itself and/or biological growth (if water is present in the fuel). The soap formed was viscous and highly polar, capable of adhering to metal surfaces and “gumming up the works.” The presence of copper and zinc can accelerate such a process. Standard fuel tests currently in use were not effective for identifying the cause of the problem because the quantity of contaminants necessary for carboxylate formation which cause the injector failure was extremely small. The immediate solution to prevent injector failure was to prevent or remove formation of the deposits rather than try to identify the presence of contaminants in the fuel.

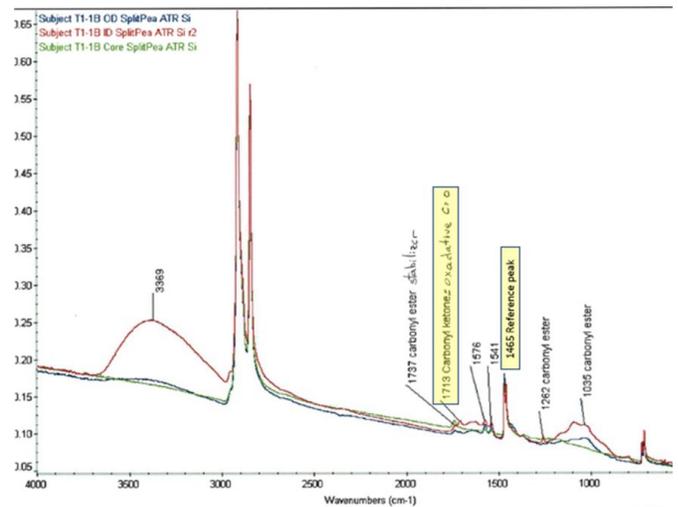
degradation. In particular, it is used to identify carbonyl groups that can be used to quantify the extent of oxidation through what has been termed the "Carbonyl Index" or CI. The carbonyl index can be calculated by taking a ratio of the height of the ketone C=O peak 1713 cm<sup>-1</sup> to the height of reference peak of the backbone of the polymer 1465 cm<sup>-1</sup> (Figure 23). Research has shown that carbonyl indices of the interior of polyethylene pipes below 0.02 indicate no significant oxidation while a CI above 0.1 denotes severe oxidation and embrittlement that may lead to pipe failure.

Figure 23 - FTIR spectra showing carbonyl and reference peaks for determining the "Carbonyl Index."

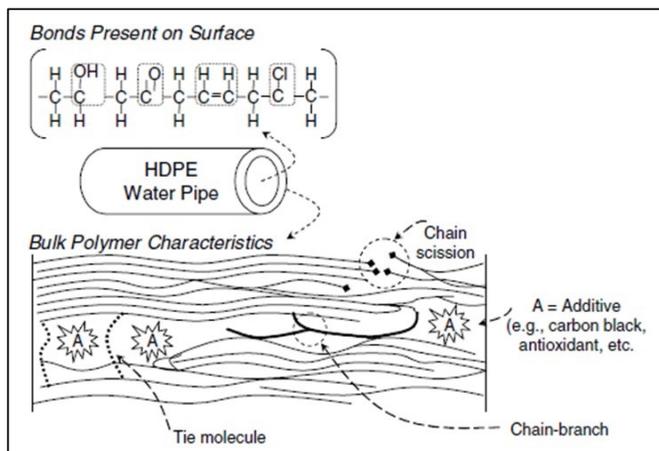
Service lifetimes for domestic water PE pipes is around 40 years. The working lifespan of pipes used in water distribution networks depends on the material's retention of its antioxidant package. For PE pipes used in water distribution networks, the diffusion and loss of antioxidant from the material is driven from the inner pipe surface. When chlorine is present in the water, it can increase the depletion rate of the antioxidant. Figure 22 shows a representation of PE degradation in chlorinated drinking water systems. Oxidation of the PE leaves behind reaction species in the pipe wall such as vinyl groups (C=C), chlorine groups, and carbonyl groups (C=O). These species do not exist in significant amounts on non-degraded pipe. The presence of these chemical groups is one of the first indicators of degradation and can lead to polymer chain scission and mechanical failure resulting in crack propagation through the pipe wall. FTIR can detect these chemical bond changes that indicate the incipient oxidative processes before the pipe materials show visible signs of

Figure 22 - Representation of chemical bonds and degradation pathways of polyethylene pipe in chlorinate water.
